EXHIBIT L

REPORT FOR *AHERN v. SIG et al.***Factual Background**

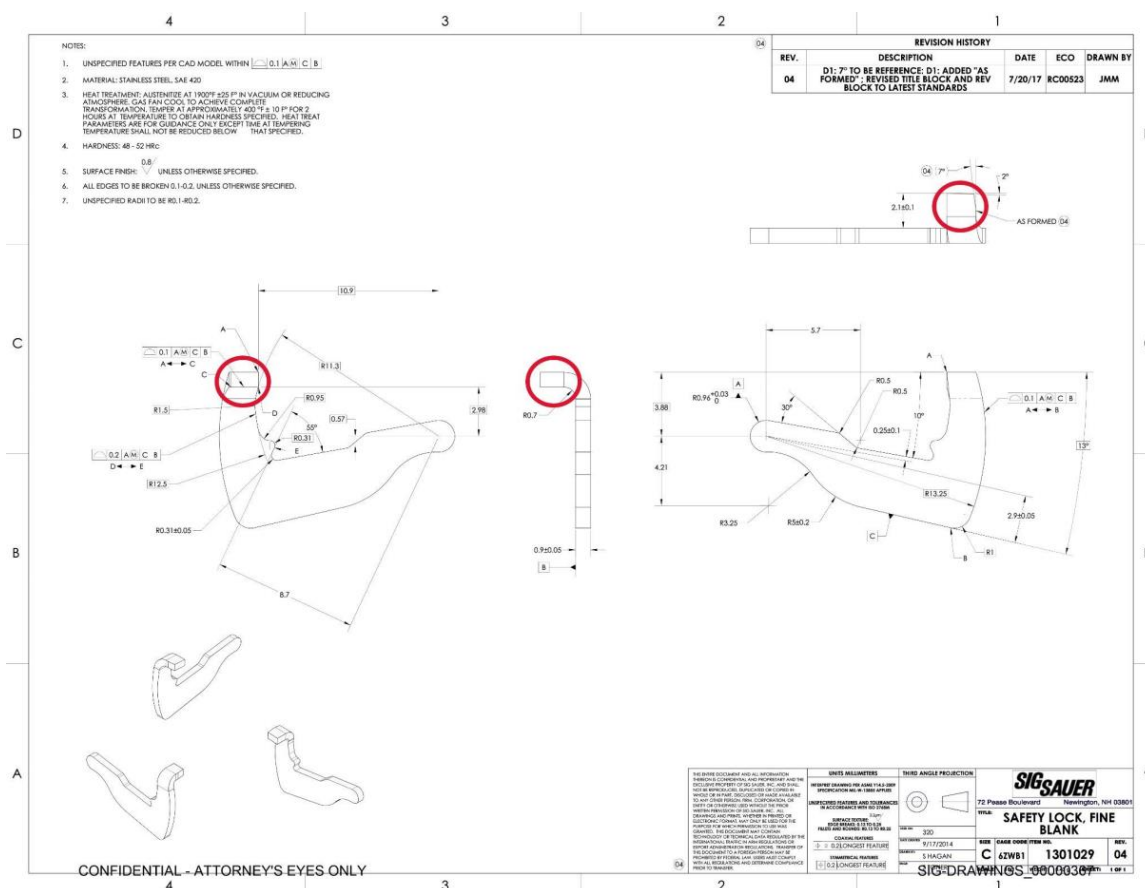
After removing the safety lock from the striker assembly, I was able to see that the tab was deformed and did not match the drawings of Sig Sauer's provided engineers' plans (below).

14. The safety lock is a stamped steel part where the tab portion is bent in a 90° turn horizontally to allow contact with the striker stop if the sear/striker engagement should fail. Also, along the bottom horizontal portion of the tab, there is an extended deformity protruding from the "positive contact surface" which again prevents a positive interface between the striker stop and safety lock tab should the sear/striker fail.

Sig Sauer official drawings of safety lock showing squared off and rectangular edging along the tab area (circled in red)
